17 March 2020 - Attachment 8.1.1a

**Kevin Lodge MIEAus.CPEng.
3 Pember Rd E,
Denmark 6333
Ph/Facs 9848 2790
6th Feb. 2019
Job 690-1/19
Page 1 of 5**

**REPORT; JOHN CLARKE MEMORIAL BANDSTAND
STRUCTURAL INTEGRITY & OPTIONS FOR FUTURE TREATMENT**

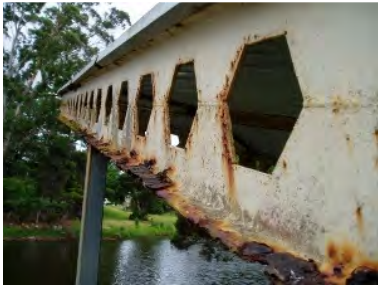
RBS – Roof Beam South

| No. | COMPONENT | CONDITION | TREATMENT |
|---|---|---|---|
| 2 | Roof beam south – RBS. 405mm deep Castellated steel U beam. | Nearing Failure due to advanced rusting. Capacity not readily assessible. | <u>Replace</u> with similar. – a newly fabricated beam should be hot dipped galvanized. This major element is beyond repair. |

1. The steel castellated roof beams, RBS [most severely rusted, because it is exposed to southerly rainy, salt laden, weather] & RBN have rusted beyond repair. Replacement of both is required.

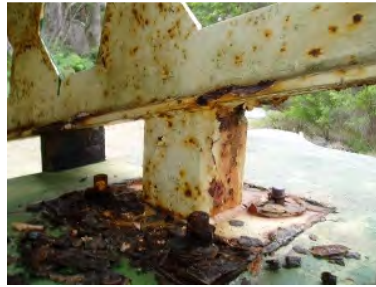
SCS – Stub columns South

| No. | COMPONENT | CONDITION | TREATMENT |
|---|---|---|---|
| 8 | Stub col & baseplate [steel] supporting beams at Pier South. - SCS | Failed, due to excessive rusting. | <u>Replace</u> . New stub-column & baseplate will be part of the new RBS [all HDG]. New plate will be of a greater dimension, to allow for drilling into the concrete capping and epoxy fixing new bolts. |

2. Stub columns & baseplates SCS & SCN, have rusted beyond repair. These are welded onto the roof beams, so are an integral part of them. Replacement of both is required.

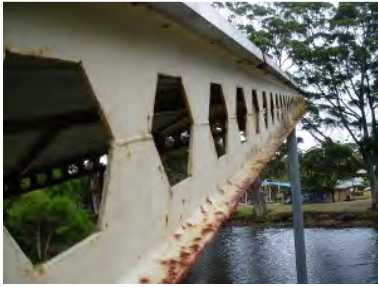
RBN – Roof Beam North

| No. | COMPONENT | CONDITION | TREATMENT |
|---|---|---|---|
| 3 | Roof beam north – RBN. 405mm deep Castellated steel U beam. | Nearing Failure due to advanced rusting. Whilst not deteriorated as far as RBS, it's capacity is not readily assessible. | <u>Replace</u> with similar. – a newly fabricated beam should be hot dipped galvanized. This major element is beyond repair. |

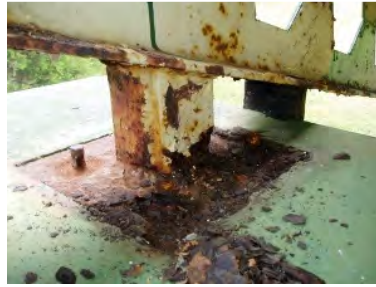
SCN – Stub columns North [western view]

| No. | COMPONENT | CONDITION | TREATMENT |
|---|---|---|---|
| 9 | Stub col & baseplate [steel] supporting beams at Pier North. - SCN | Failed, due to excessive rusting. | <u>Replace</u> . New stub-column & baseplate will be part of the new RBN [all HDG]. New plate will be of a greater dimension, to allow for drilling into the concrete capping and epoxy fixing new bolts. |

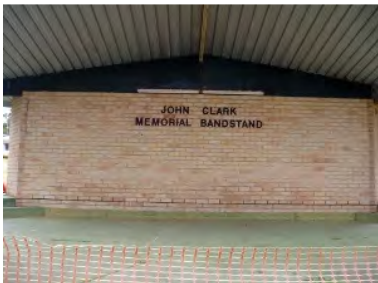
West Elevation - brickwork

3. Brickwork piers PS & PN, are good condition – acceptable to retain.
4. Brickwork to changerooms BWS & BWN, are good condition – acceptable to retain.

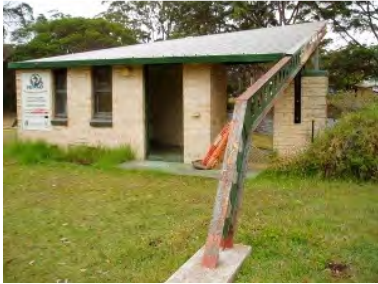
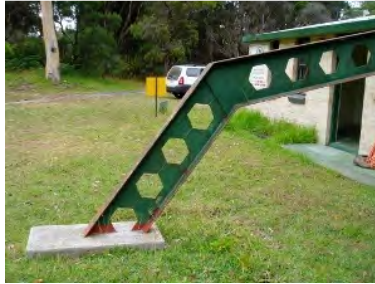
North east Elevation – Pad footing PFN, to Roof beam RBN

| No. | COMPONENT | CONDITION | TREATMENT |
|---|---|---|---|
| 7 | Roof beam north – concrete pad footing - PFN | Acceptable | Should the beam [RBN] be replaced, then this PFS <u>would be replaced</u> , requiring re-engineering of it's size, and the tie-down fixing to a substitution of a baseplate [galvanized] to the end of the beam. |

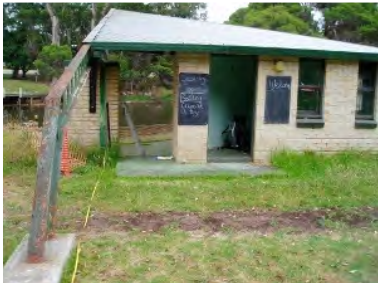
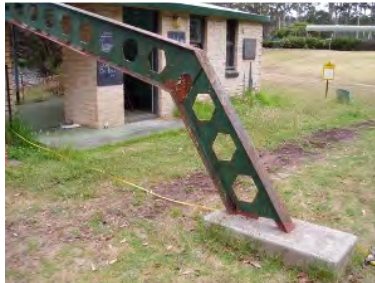
South east Elevation – Pad footing PFS, to Roof beam - RBS

| No. | COMPONENT | CONDITION | TREATMENT |
|---|---|---|---|
| 6 | Roof beam south – concrete pad footing - PFS | Acceptable | Should the beam [RBS] be replaced, then this PFS <u>would be replaced</u> , requiring re-engineering of it's size, and the tie-down fixing to a substitution of a baseplate [galvanized] to the end of the beam. |

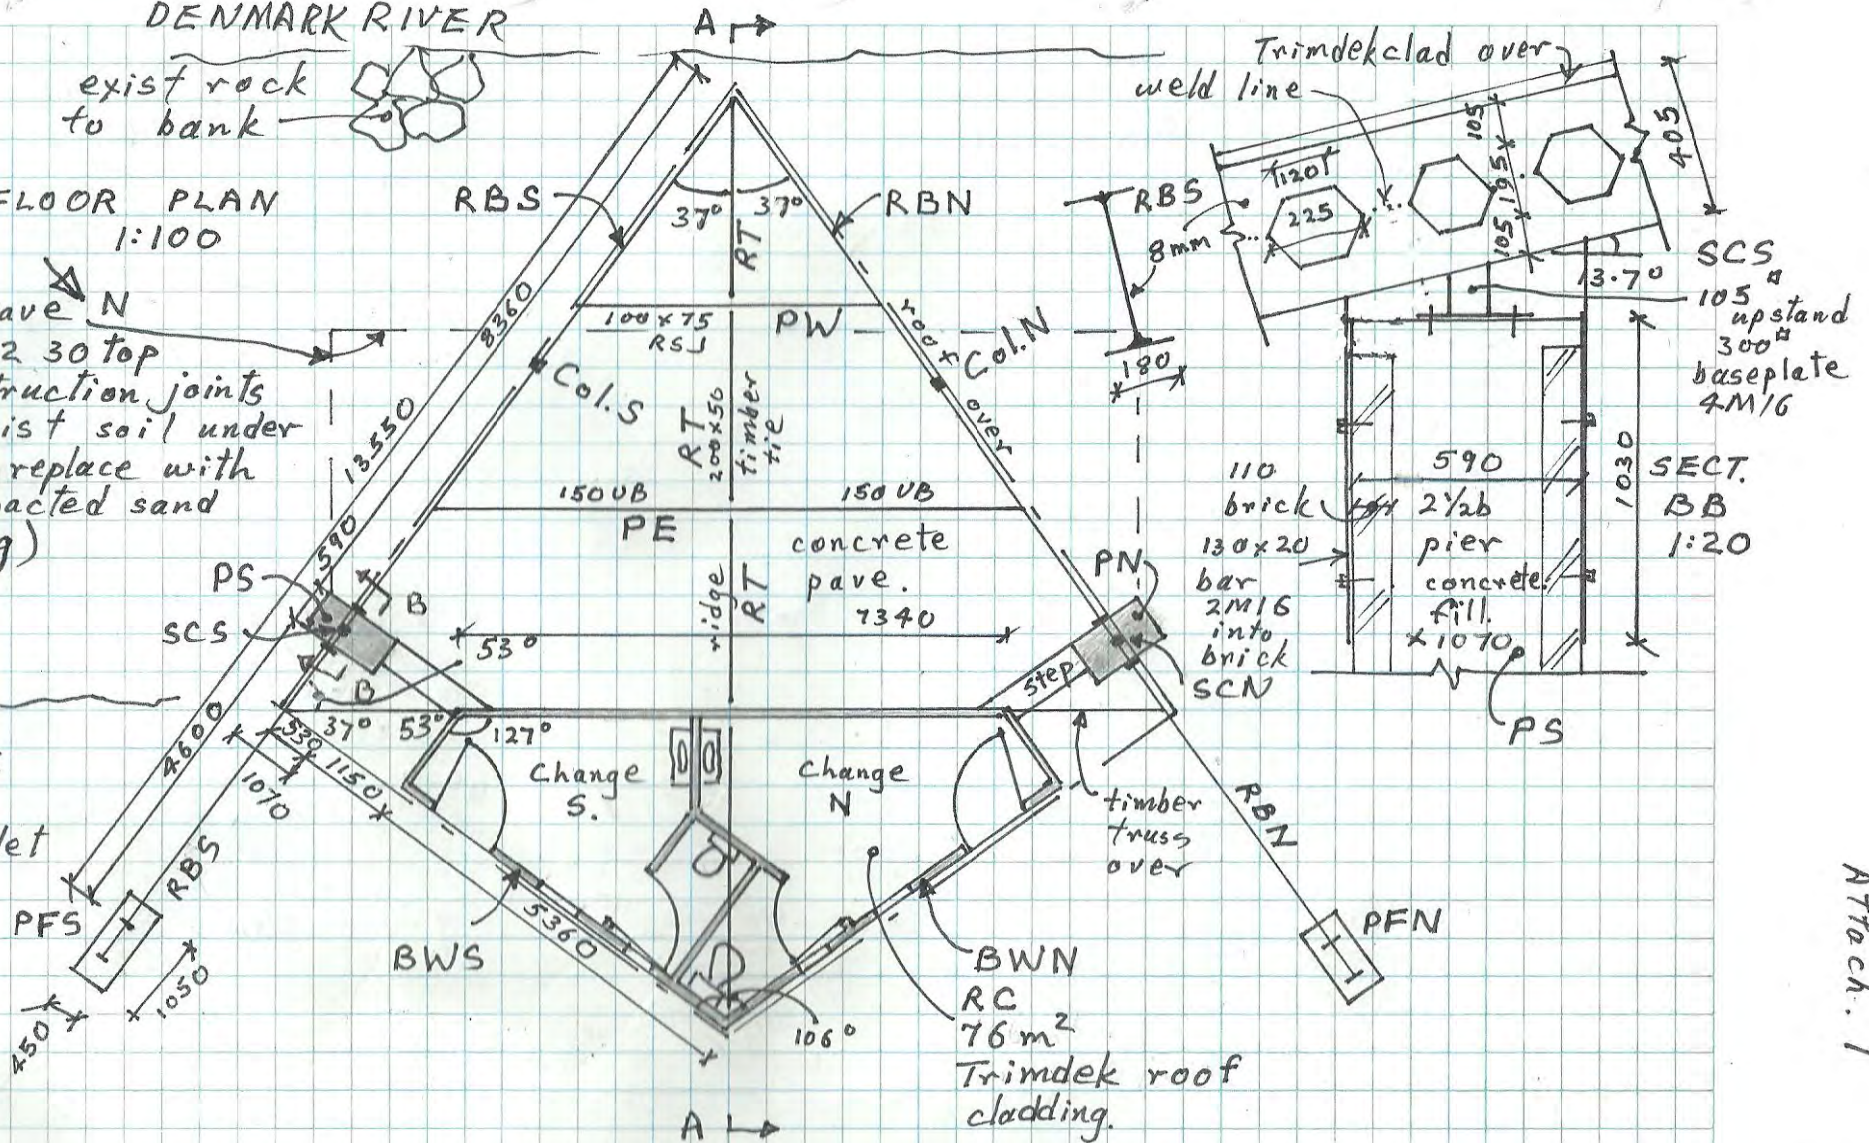
FLOOR PLAN
1:100

Extent of
inundation
prior to inlet
opening.

Concrete pave N
100 mm SL72 30 top
with construction joints
Remove exist soil under
500 deep & replace with
clean compacted sand
(if replacing)
