17 March 2020 - Attachment 8.1.1a

**Kevin Lodge MIEAus.CPEng.
3 Pember Rd E,
Denmark 6333
Ph/Facs 9848 2790
6th Feb. 2019
Job 690-1/19
Page 1 of 5**

**REPORT; JOHN CLARKE MEMORIAL BANDSTAND
STRUCTURAL INTEGRITY & OPTIONS FOR FUTURE TREATMENT**

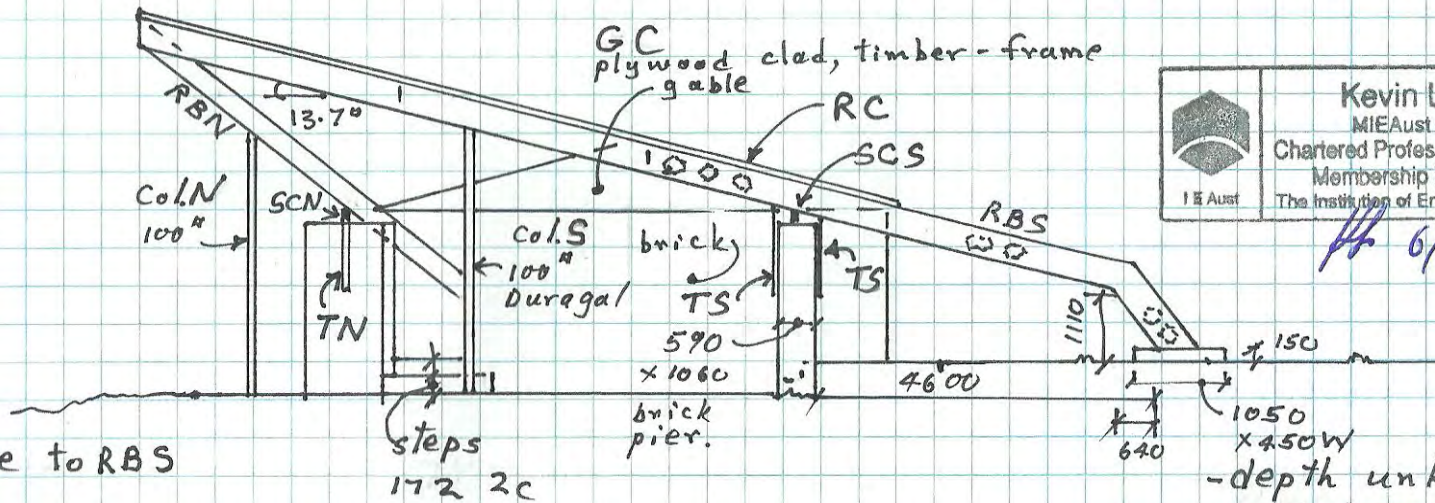
SOUTH ELEVATION
1:100 - square to RBS

| No. | COMPONENT | CONDITION | TREATMENT |
|---|---|---|---|
| 2 | Roof beam south – RBS. 405mm deep Castellated steel U beam. | Nearing Failure due to advanced rusting. Capacity not readily assessible. | <u>Replace</u> with similar. – a newly fabricated beam should be hot dipped galvanized. This major element is beyond repair. |

1. The steel castellated roof beams, RBS [most severely rusted, because it is exposed to southerly rainy, salt laden, weather] & RBN have rusted beyond repair. Replacement of both is required.
